ELLIOT DAVIS LAKE DAM  
HOWARD COUNTY, MISSOURI  
MO 10129

PHASE 1 INSPECTION REPORT  
NATIONAL DAM SAFETY PROGRAM

PREPARED BY: HOSKINS-WESTERN-SONDEREGGER, INC.  
FOR: STATE OF MISSOURI

SEPTEMBER, 1978

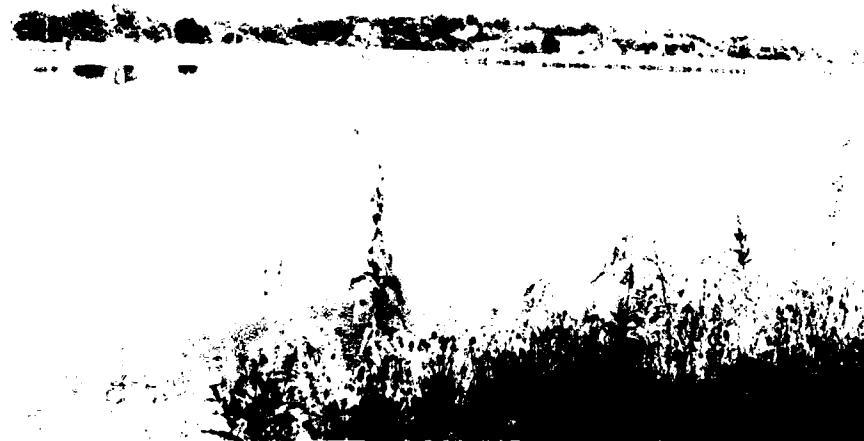
PHOTO NO. 3  
OVERVIEW OF DAM  
TAKEN UPSTREAM  
FROM RIGHT ABUTMENT.

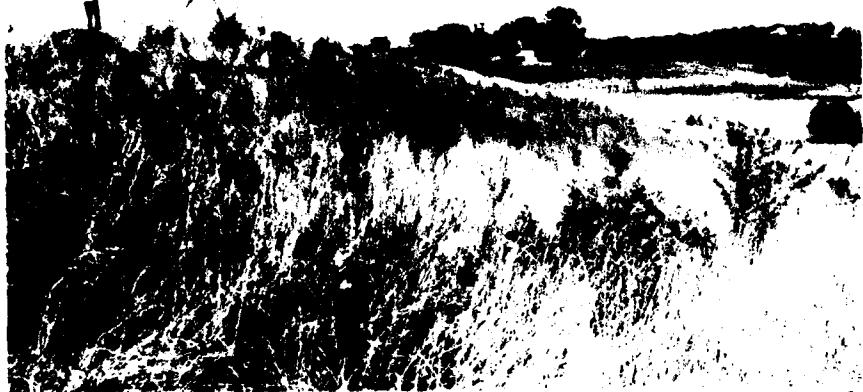
- c. Appurtenant Structures. The principal spillway consists of a 30 inch corrugated metal riser connected to a 12 inch CMP outlet passing through the dam or abutment at about 6 station 10+50. A dense growth of tall grass and rushes encloses the screen around the concrete weir inlet to the spillway. The spillway outlets on the right abutment about 13 feet above the elevation of the valley floor. A hole about 20 feet in diameter has eroded around the outlet end and exposed about 4 feet of the spillway pipe. The exposed c/m pipe appeared to be in good condition. However, it was reported by one of the owners that the 12 inch spillway conduit pipe is broken and leaks. Leakage from the spillway outlet could contribute to the seep area along the toe of the dam.

The erosion around and leakage in the spillway outlet could lead to potential of failure if left uncorrected. Additional studies would be required to determine the affect of seepage on stability of the dam. The flat side slopes on this embankment would ordinarily provide adequate safety against shear failures for a dam of this height.

PHOTO NO. 6  
OUTLET END OF  
PRINCIPAL SPILLWAY

- (1) Raising the low sections on each end of the dam up to the normal crest elevation of 703 would prevent overtopping by the 0.5 PMF.
- (2) An emergency spillway should be constructed to pass the probable maximum flood without overtopping the dam.
- (3) If the present spillway is to remain in service, the outlet pipe should be repaired. The erosional damage at the outlet end of the spillway should be corrected and measures taken to control erosion from future spillway discharges.
